Out-of-Phase Sync Event Analysis

- **IEEE Phoenix Tech Conference 2023**

Steven Turner, Senior Engineer

Arizona Public Service

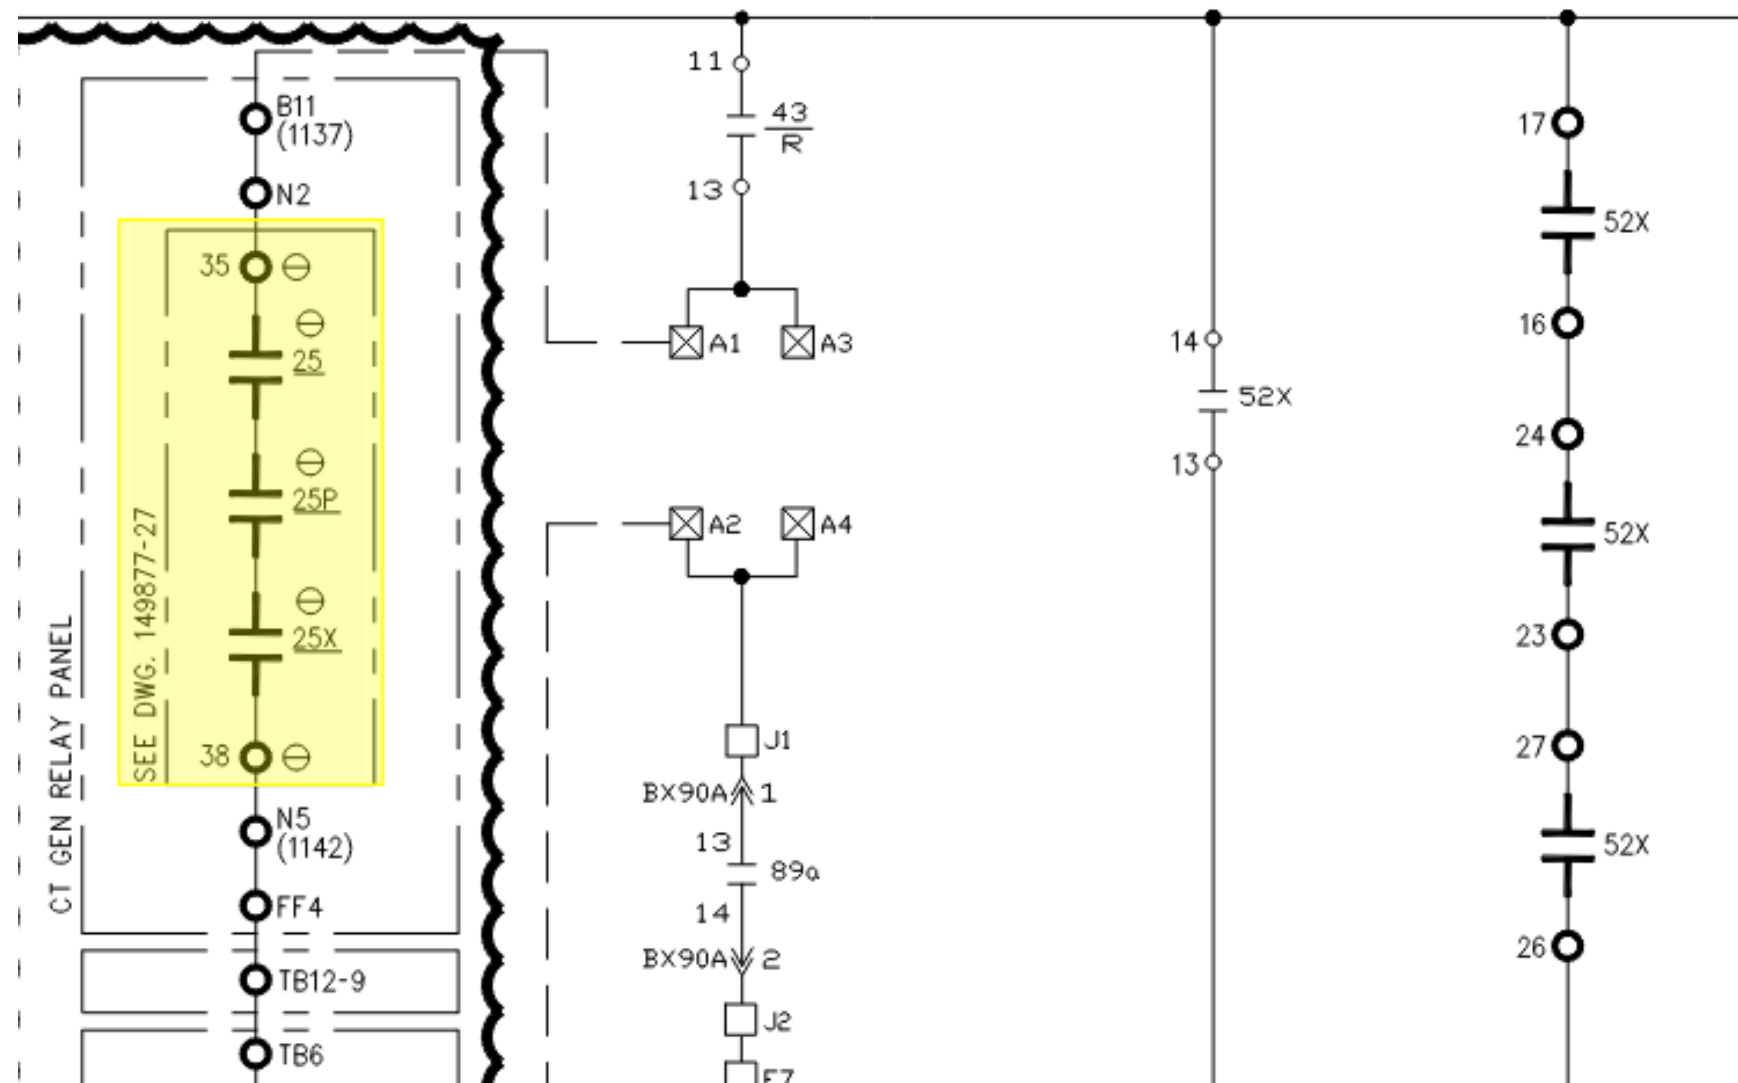
- The GCB closed out-of-phase because a high impedance input of a fault recorder monitoring the output of the sync check relay shorted, providing a positive path to the GCB close coil.
 - Protective relaying operated and opened the switchyard breakers, isolating the CCPB.
-

- The 25 sync contacts are shown below, they pick up the 52X.
- The 52X contacts pick up the 52CC close coil.

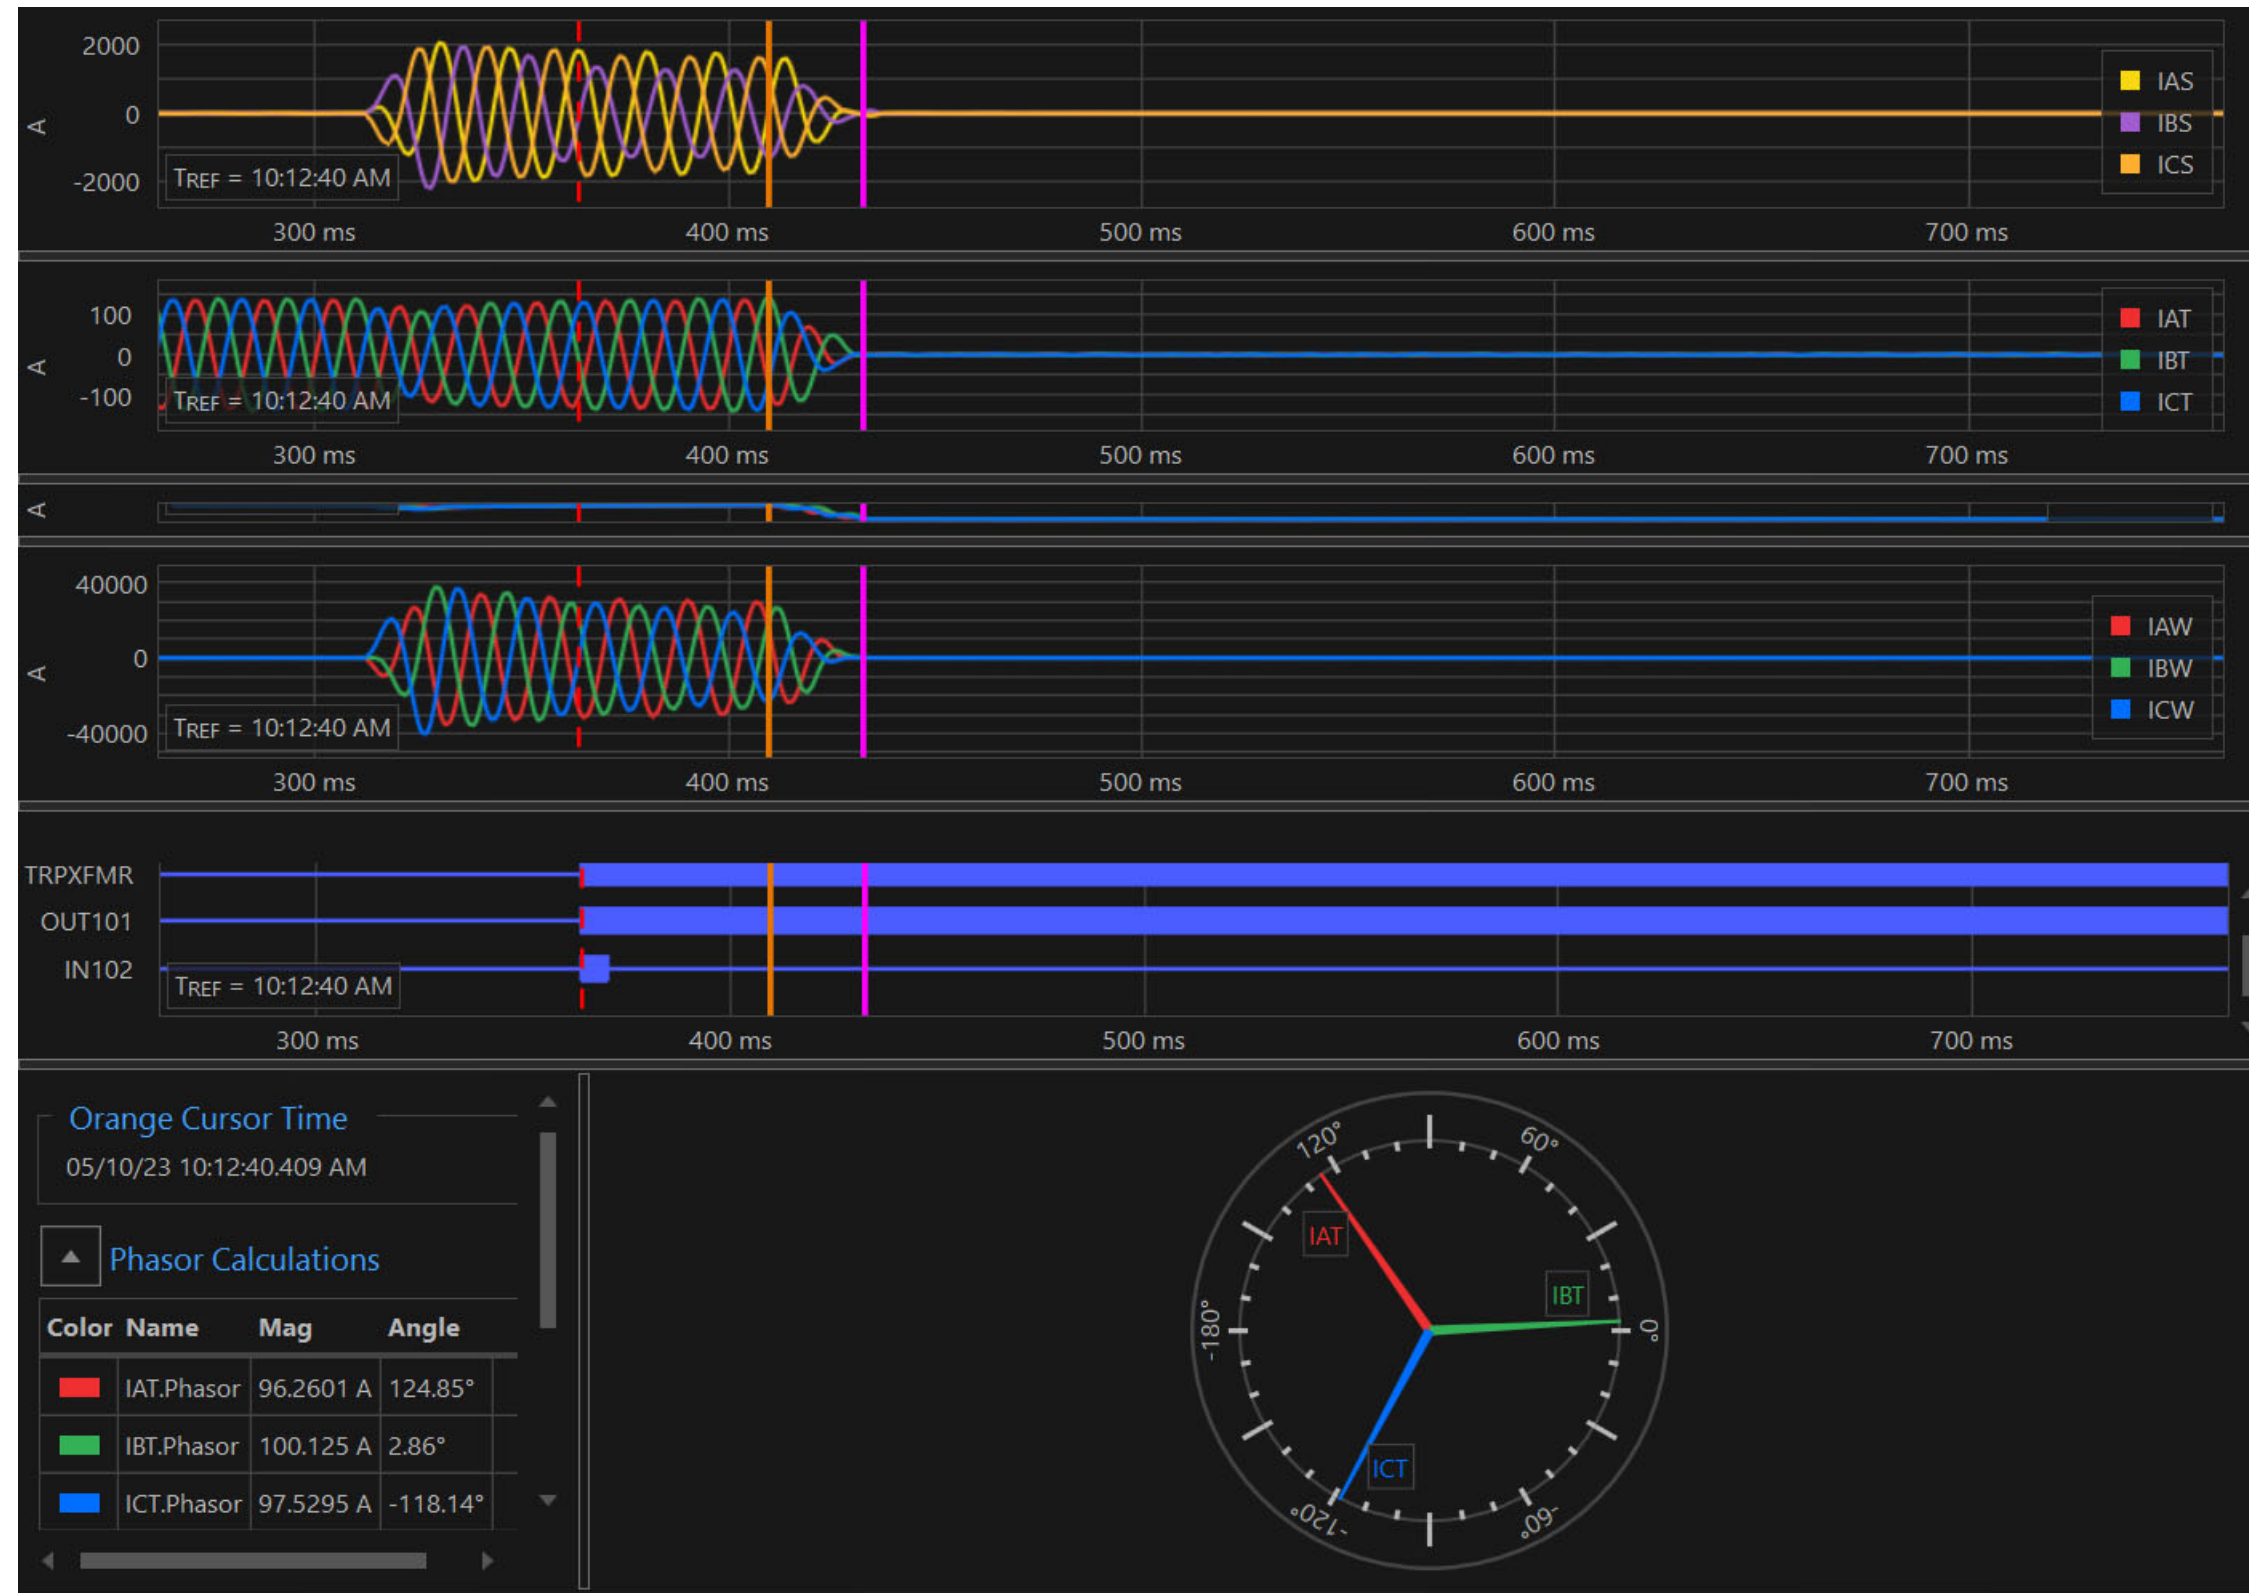
1st Trip Cont'd

- The GSU was damaged during the first event.
- The output from the sudden pressure relay (SPR) asserts the main GSU protection input IN102 three cycles into the first event, as shown in Figure 1, which in turn triggers the trip output OUT101 and sends a DTT to the switchyard breakers.
- It is assumed that there was significant transformer winding movement due to the high magnitude fault level current flowing through the GSU, resulting from the out-of-phase synch.
- The currents were interrupted three cycles later by the GCB, resulting in the generator breaker being closed for a total of 6 cycles.

- Given the short assertion time and the fact that the SPR did not assert during the subsequent re-energizations of the GSU, the SPFR chatter was due to the extreme forces in the GSU while the large fault current magnitude current was flowing.
- This is a known behavior of SPFR for high magnitude current through faults.
- The dissolved gas analysis (DGA) indicated there was a high energy electrical discharge within the transformer.
- This damage led to the internal fault on the GSU low voltage winding serving the CTG.

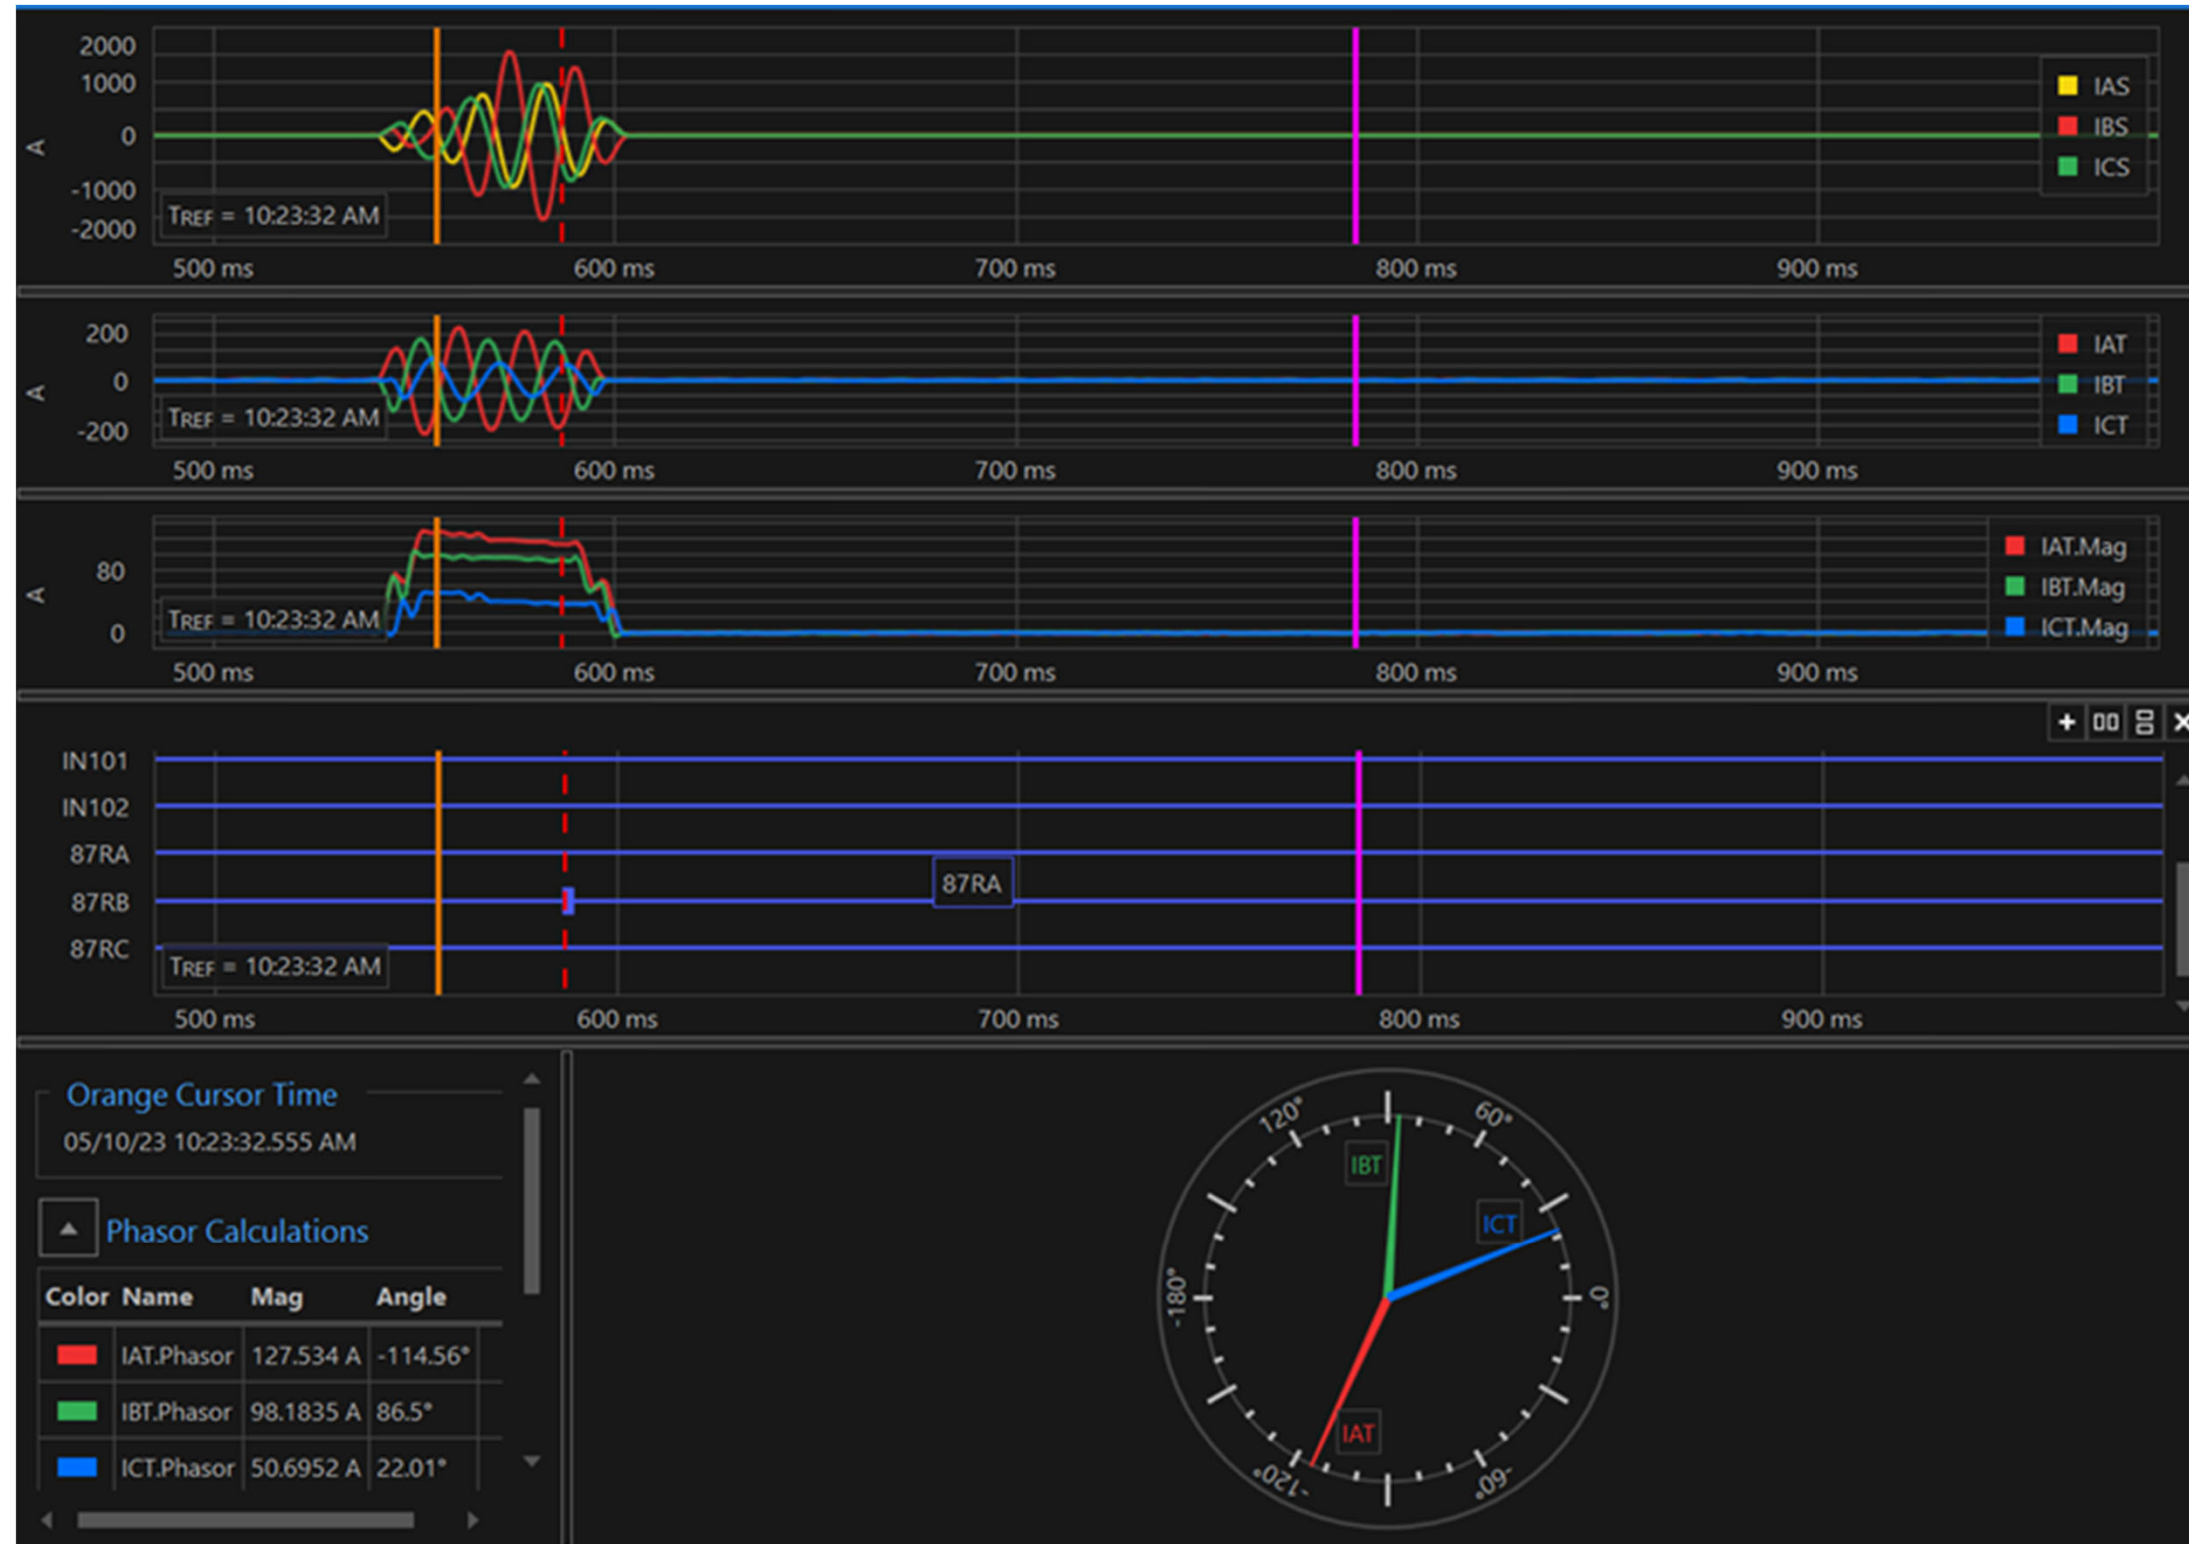
Main GSU 2nd Protection Trip

- Figures 2 and 3, to follow, are for the second and third main GSU main protection trips, due to the 87-transformer differential protection.
- The first fault was phase-to-ground, which evolved into a phase-to-phase-to-ground fault the third time the GCB was closed.

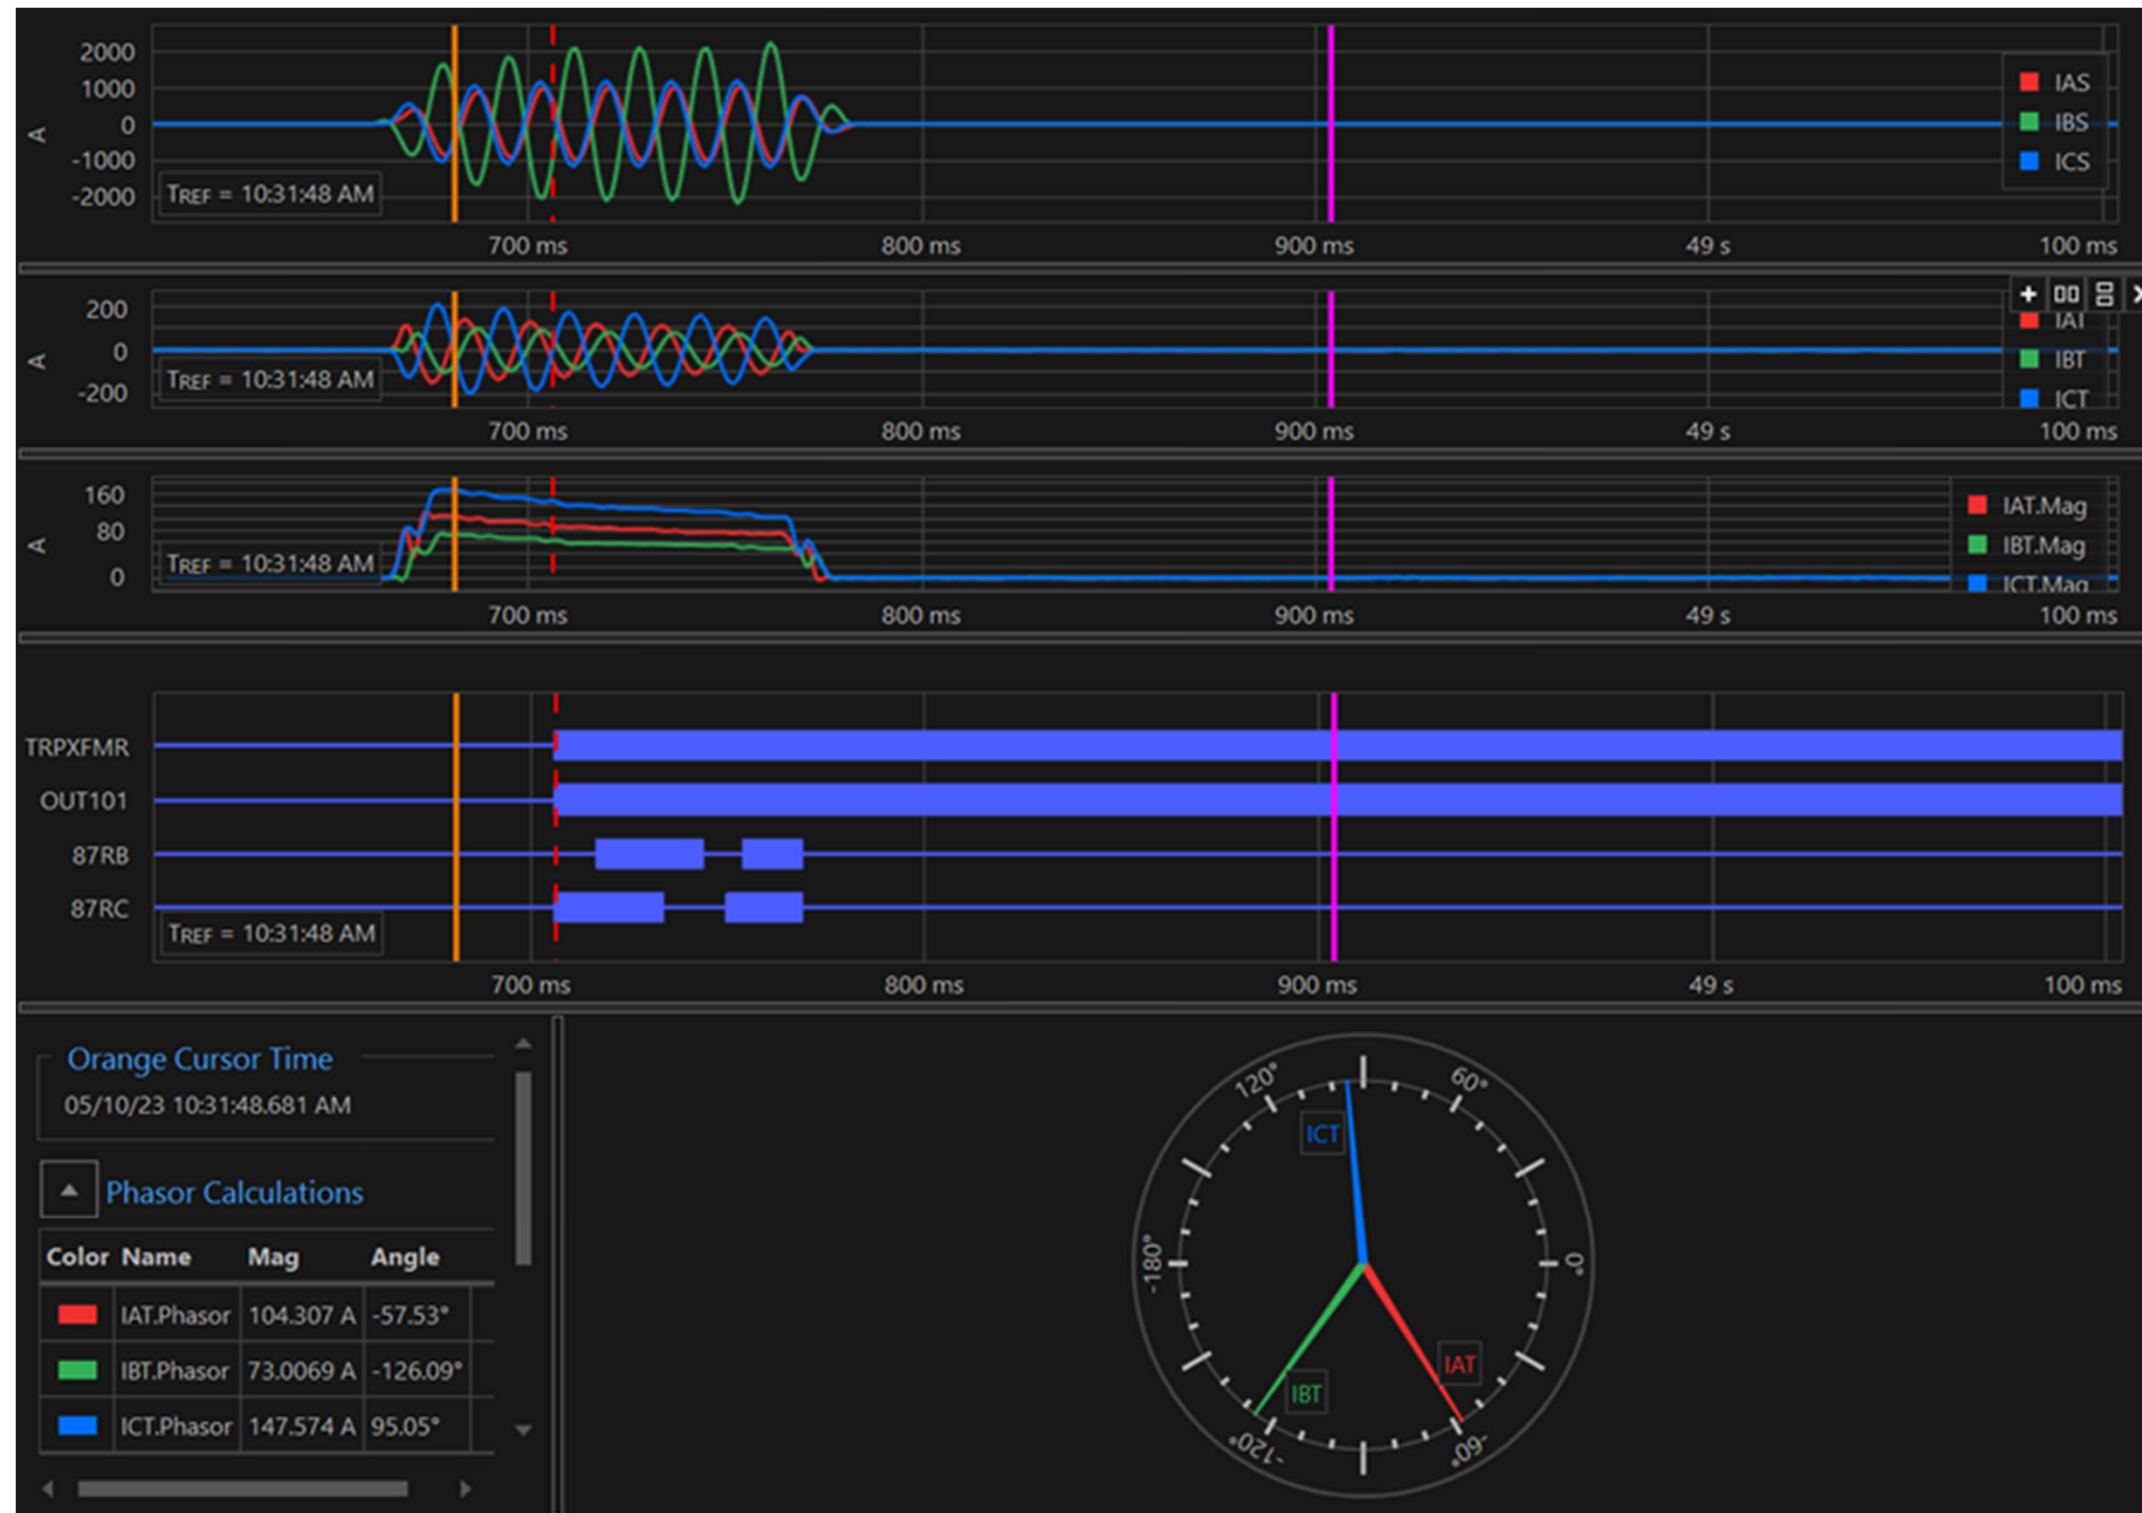
Main GSU 3rd Protection Trip

A final attempt to close the same switchyard breaker was made at 9:33 AM with the same result; this time the main GSU protection tripped on 87 phase differential protection three cycles later. The GSU was severely damaged due to a low voltage winding fault as a result and would have to be replaced.

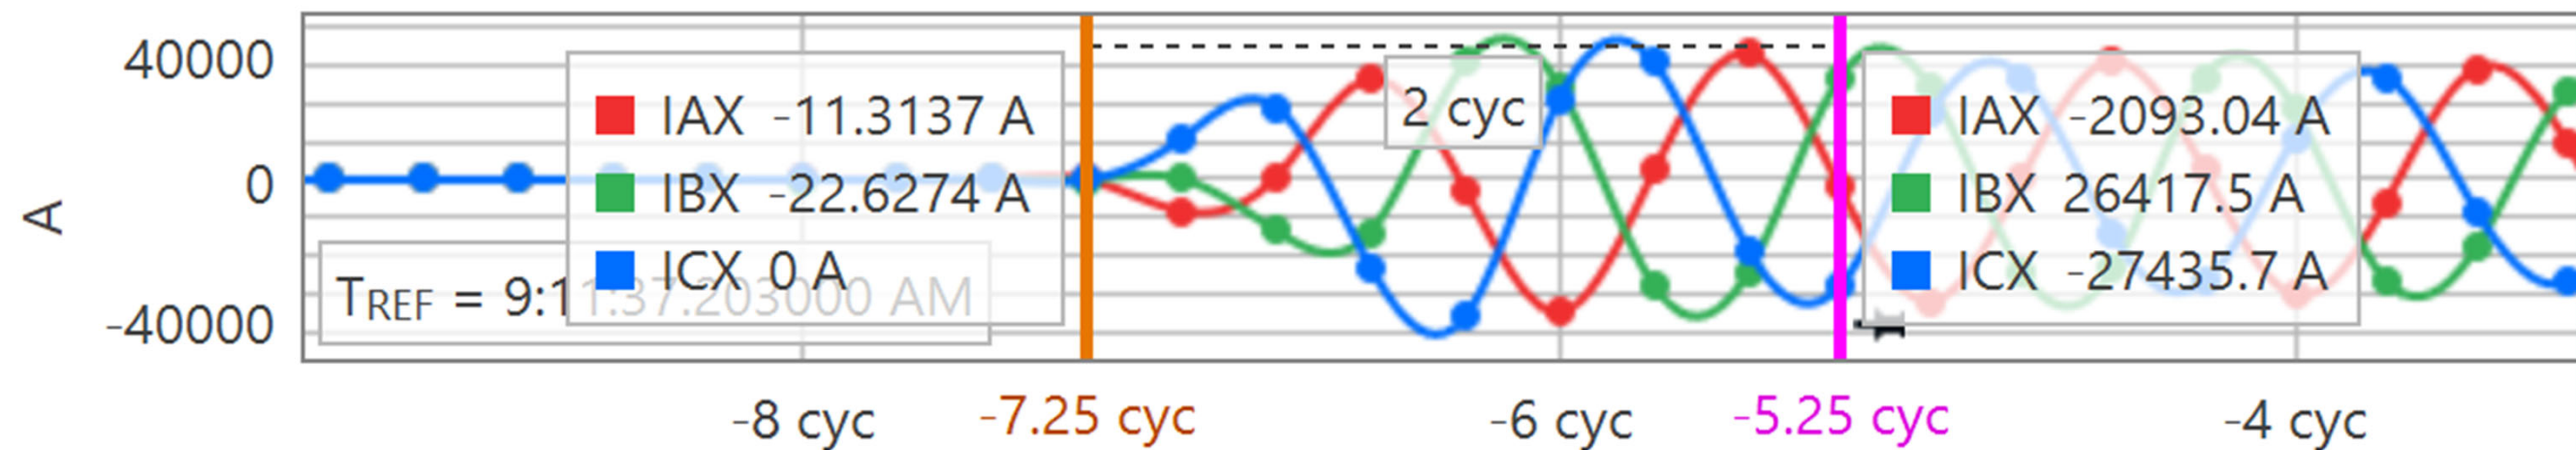
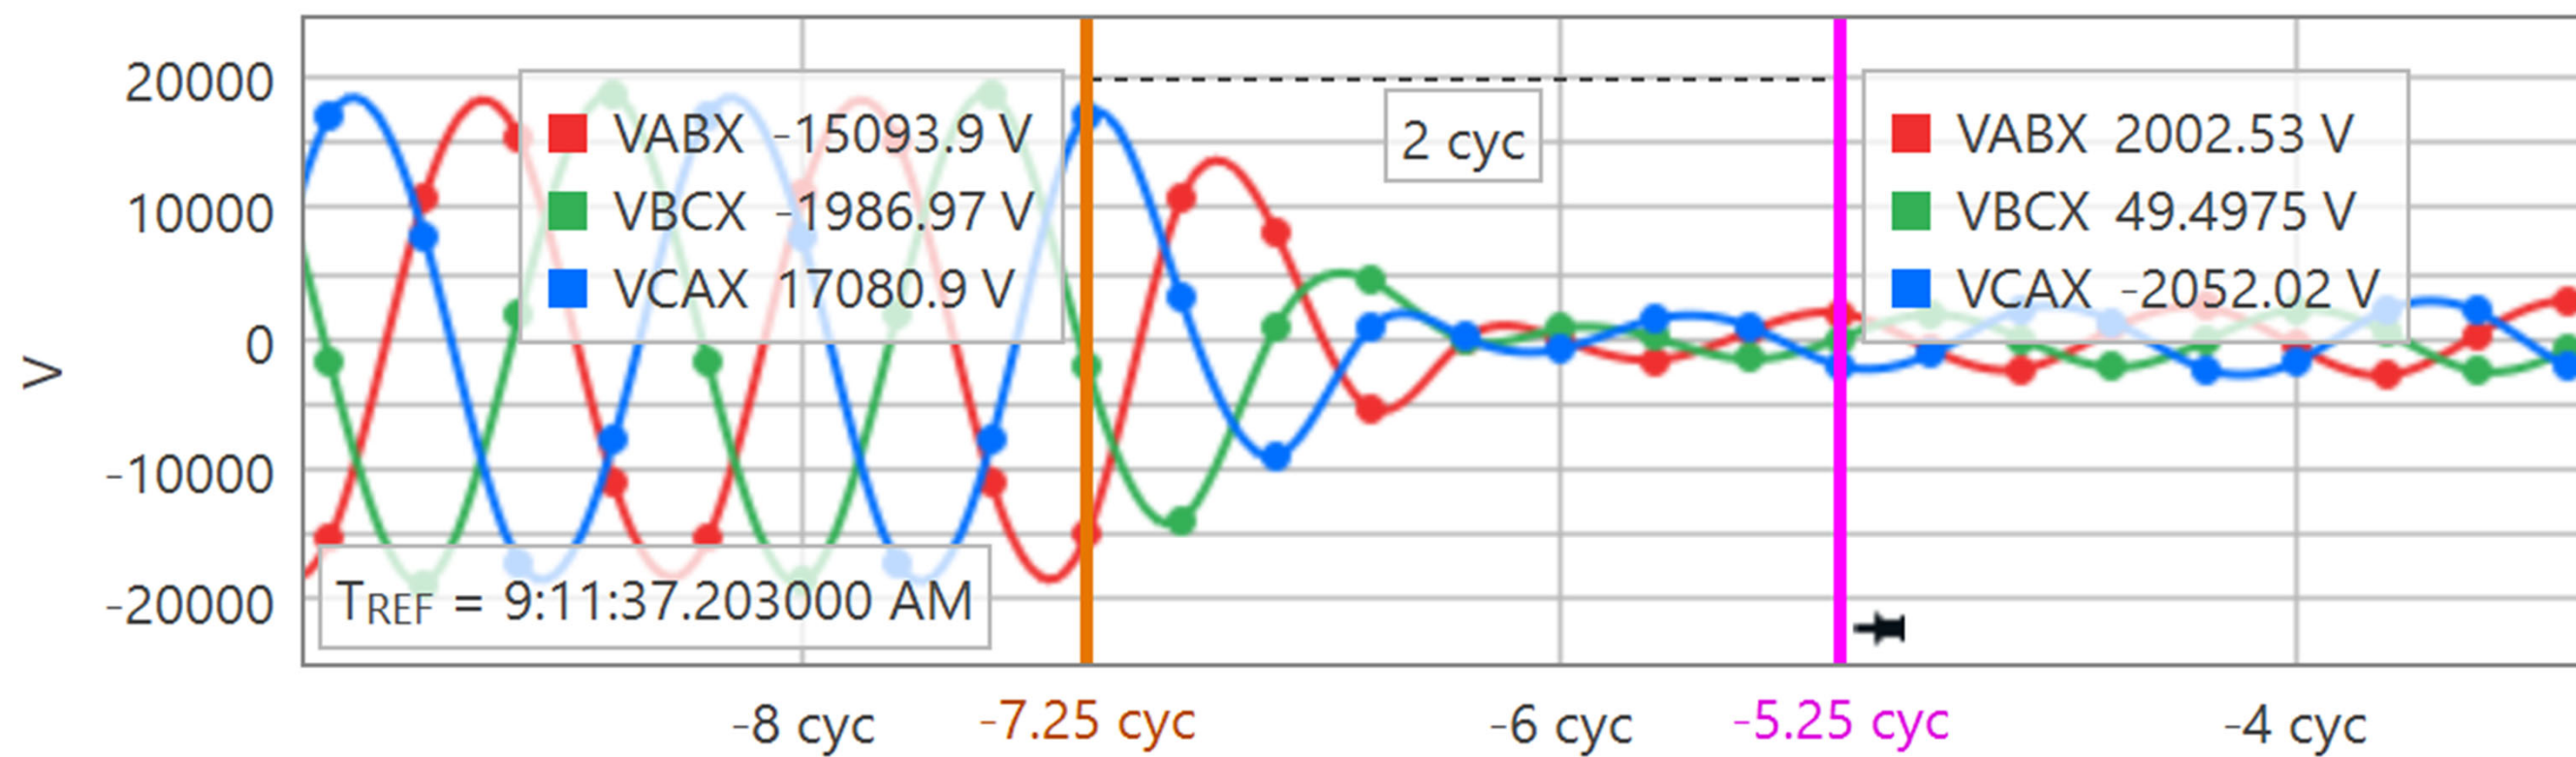
SEL CEV_10410.CEV.Session - SynchroWAVE Event

- The GCB was closed when the machine was **180 degrees out-of-phase** with the system.
- This was verified using oscillography from the second main generator protection. VCAX voltage goes in-phase with the system in only 2 cycles.
- This is because the system is much stronger, and it almost instantly rotated the shaft of the generator 180 electrical degrees to force it in-phase with the system.
- See Figure 4.

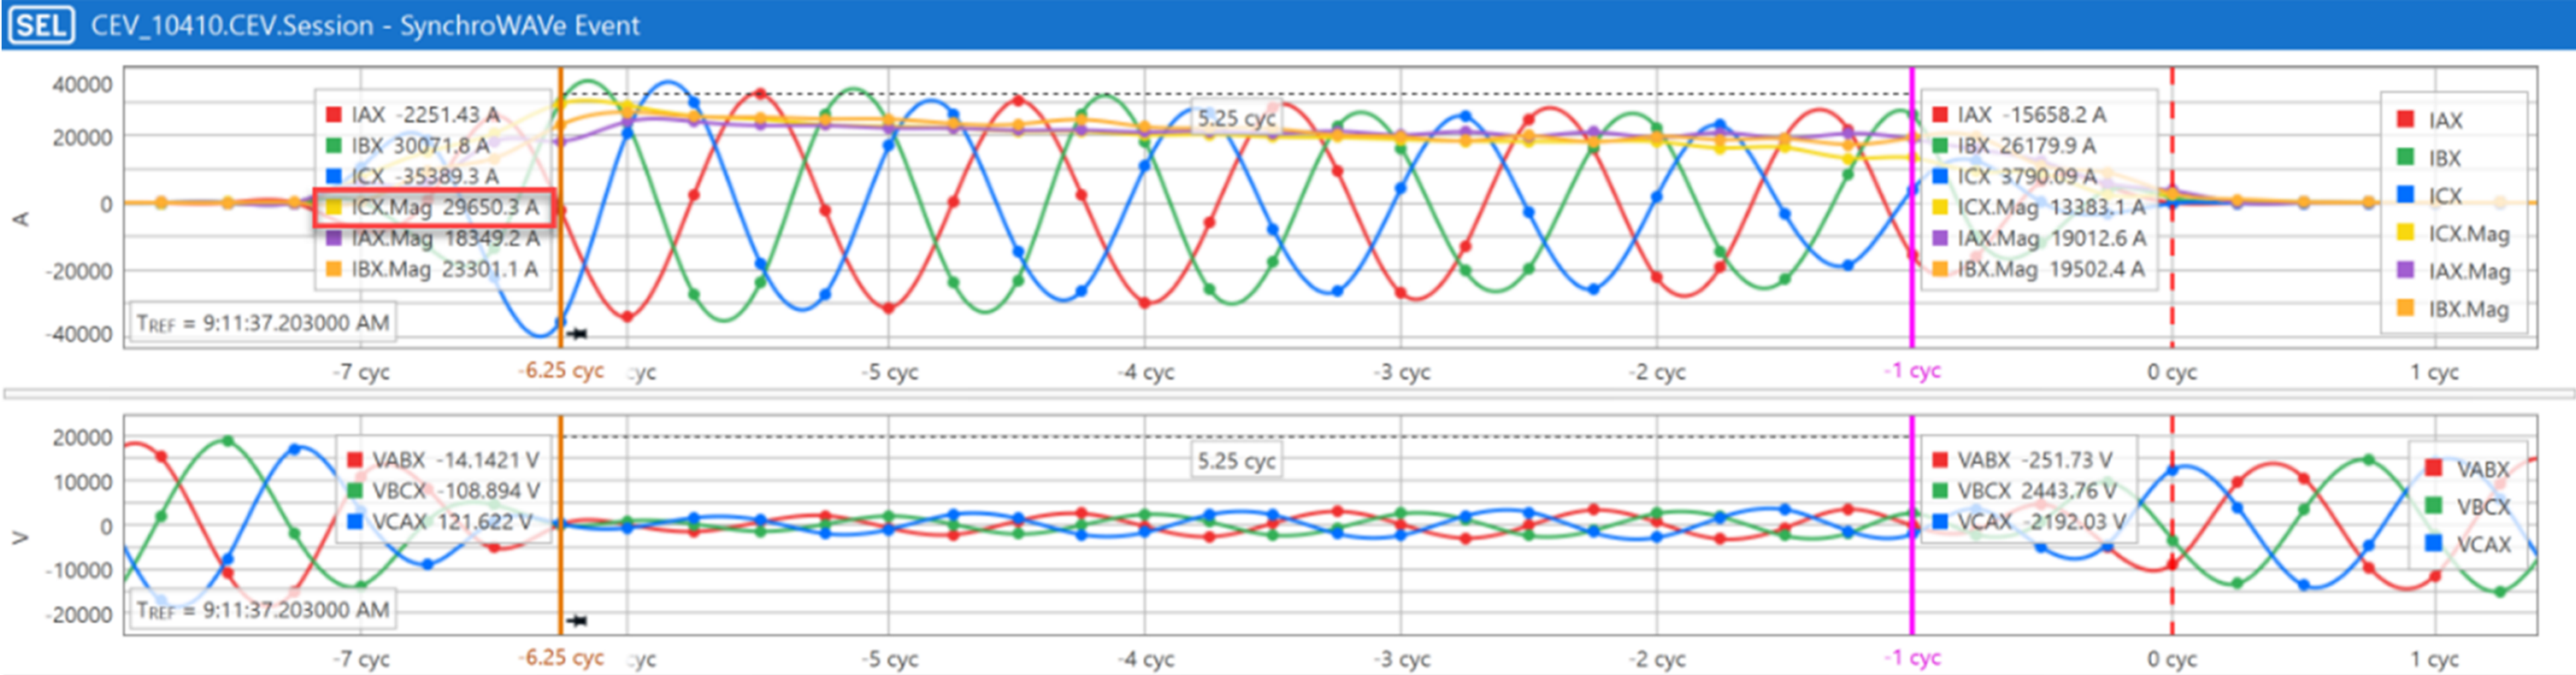
- The stator phase current grew extremely high in magnitude when the GCB was closed out-of-phase.
- The filtered current on C-phase recorded by the second main generator protection relay rose as high in magnitude as 29,650 Amps.
- A three-phase fault at the terminals of the CTG would produce 28,335 Amps based upon the saturated subtransient reactance (X_d'') of 0.158 per unit and a nominal current of 4,477 Amps.
- Based upon IEEE C50.13, IEEE Standard for Cylindrical-Rotor 50 Hz and 60 Hz Synchronous Generators Rated 10 MVA and Above, generators are built to withstand a three-phase fault right at the terminals.
- The current magnitude produced during the out-of-phase close exceeded the three-phase fault current. The generator bracing was inspected to verify it was still intact.

The filtered current on C-phase rose as high in magnitude as 29,650 Amps.

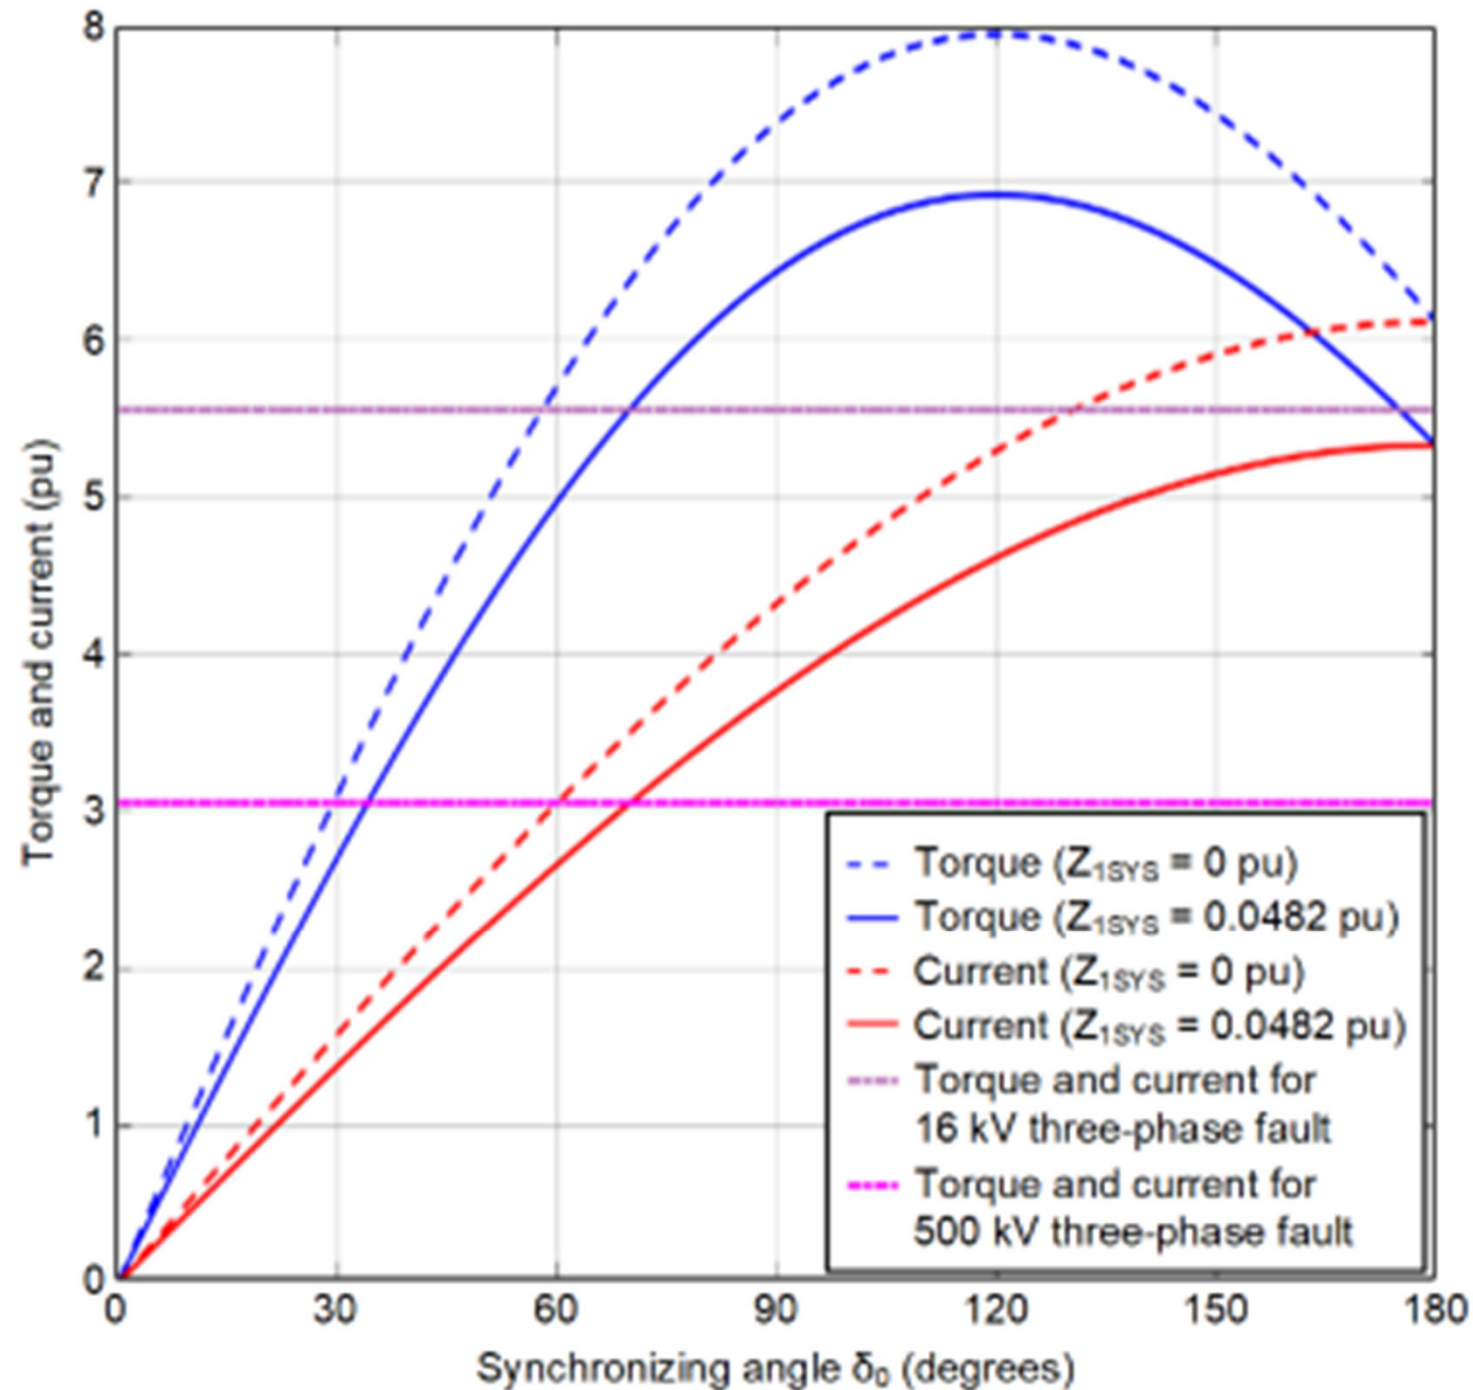
- Consider the plot, for a 60 degrees OOPS, which plots both current and torque as a function of the synchronizing angle, there is 5 per unit torque applied to the shaft.
- Therefore, it is pertinent to inspect the machine.
- The OOPS protection scheme trips the 86 lockout and shuts down the unit.
- The root cause that led to the OOPS must be determined and properly prior to another attempt to sync the machine.
