Out-of-Phase Sync Event Analysis

- **IEEE Phoenix Tech Conference 2023**

Steven Turner, Senior Engineer

Arizona Public Service

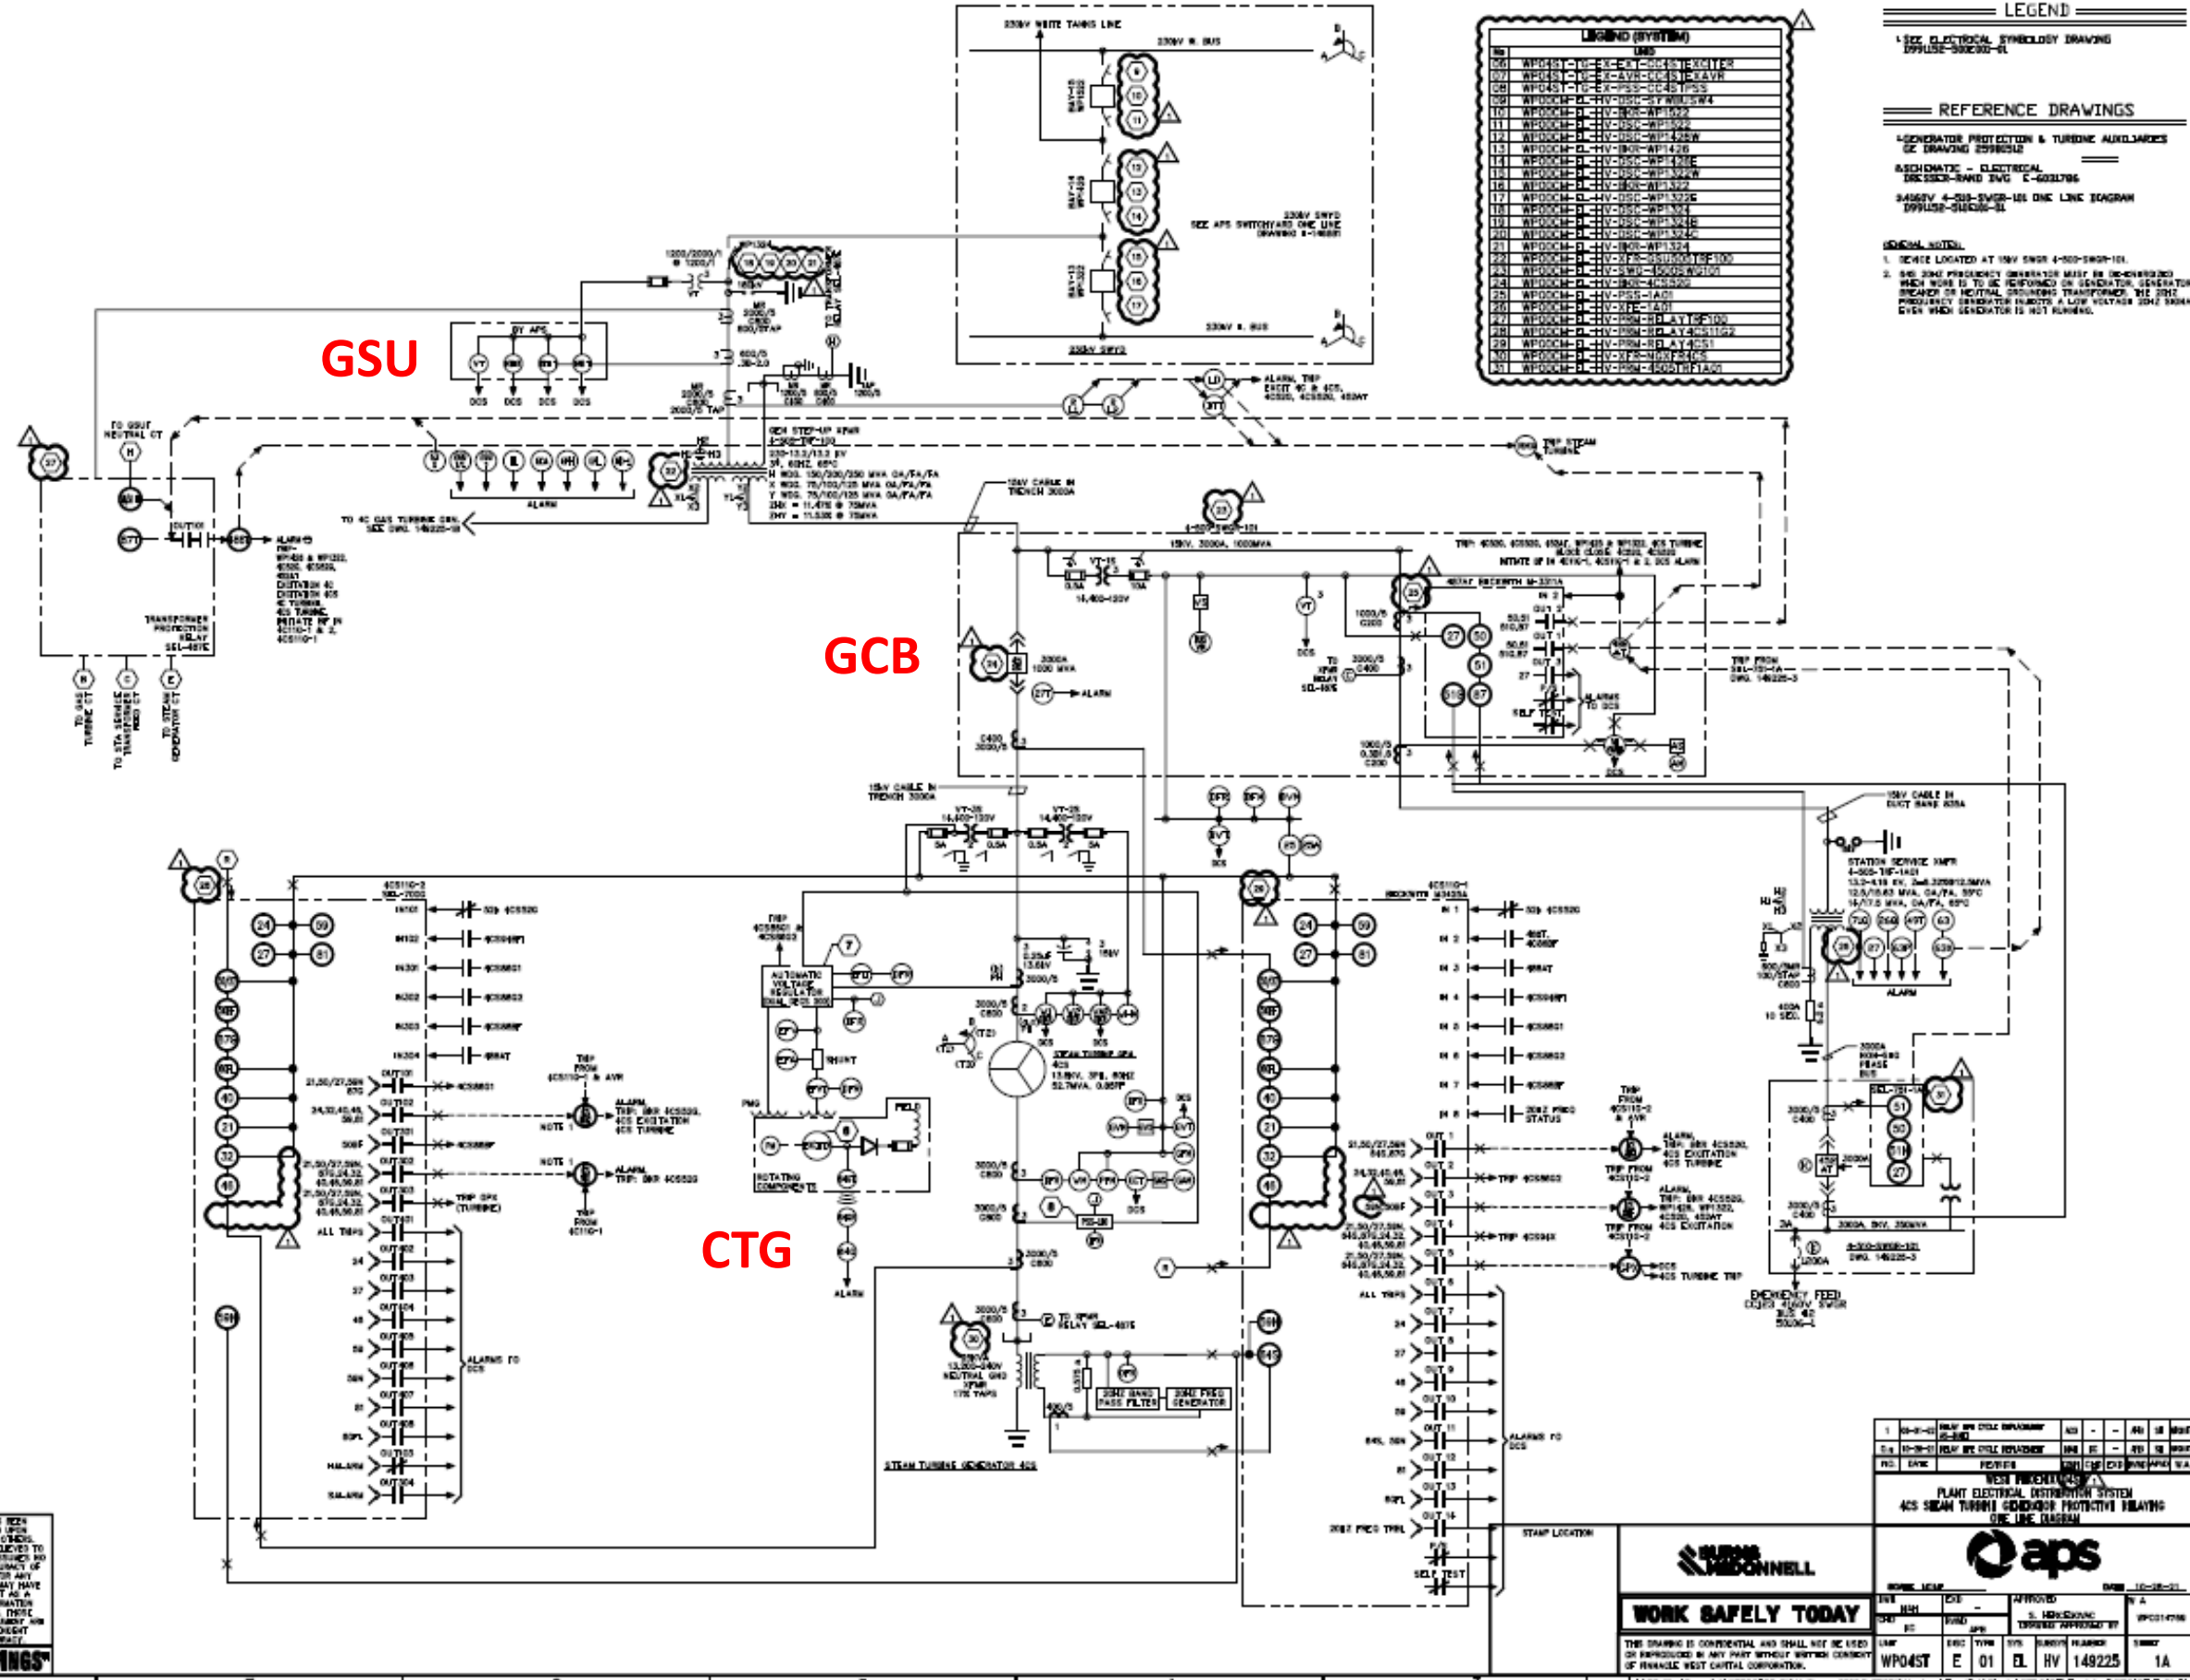
One Line

A new generator circuit breaker (**GCB**) had been installed for a combined cycle power block (**CCPB**) consisting of a gas turbine generator (**CTG**) and a steam turbine generator (**STG**).

The new GCB is located on the low side of the GSU serving the CTG. The GSU has two low side delta windings, each serving one of the two generators.

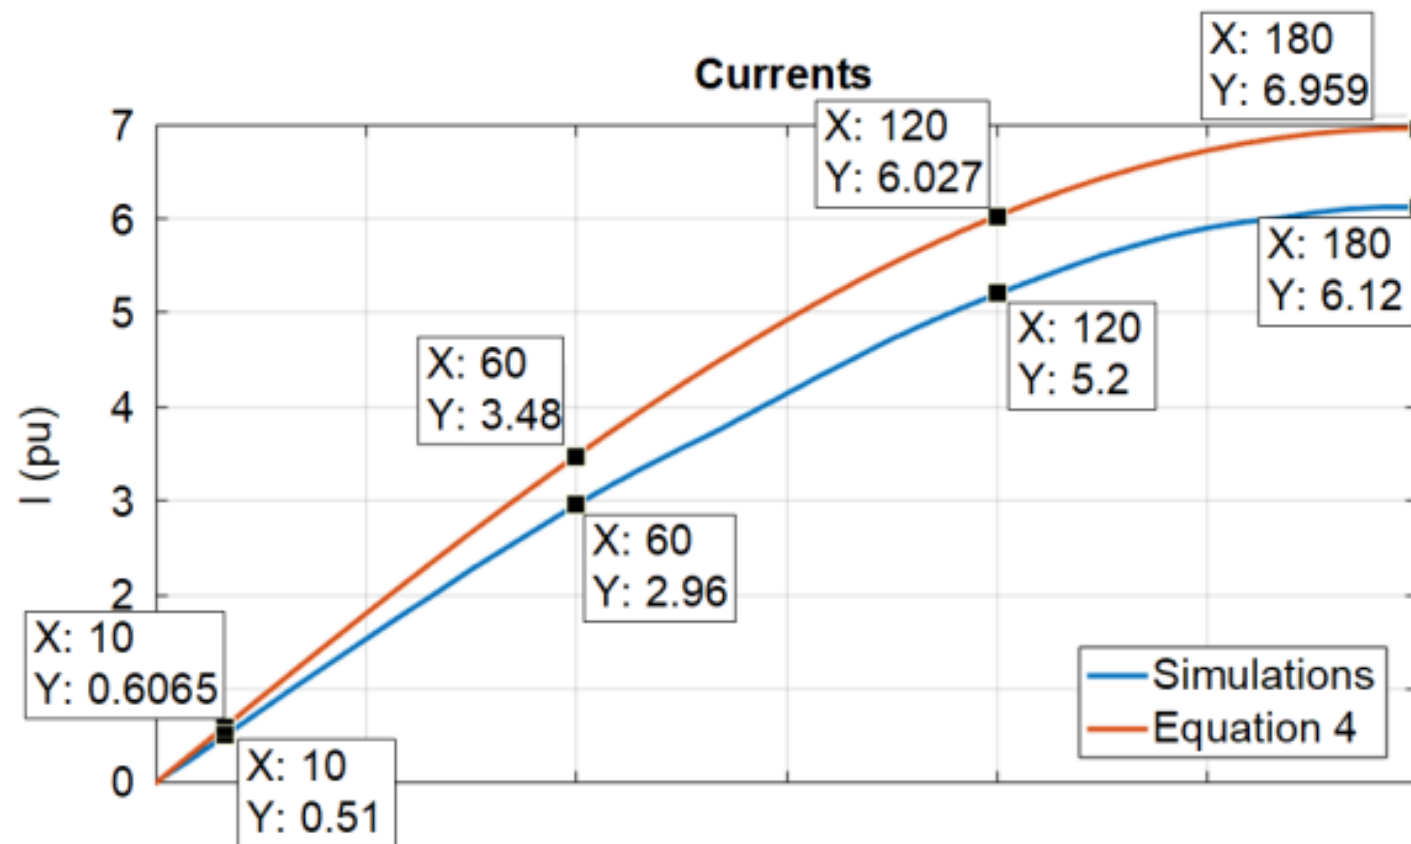
Out-of-Phase Synchronization

$$I_{AC} \approx \frac{V \cdot |1 - \angle \delta_0|}{X_{total}} = \frac{2 \cdot V}{X_{total}} \sin\left(\frac{\delta_0}{2}\right) \quad (4)$$
